## All Saints Church, Milton Keynes Village - Churchwardens Report 2022- 2023

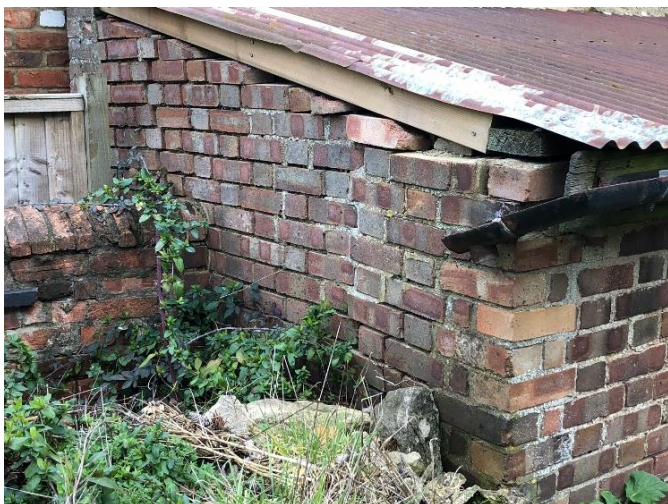
Early in the year, we identified that the roof of the mower shed was in poor condition. We replaced some of the timber frame supporting the corrugated iron covering and installed additional straps to secure it to the brickwork. The last part of the repair is to renew the flashing to the parapet wall. This will be completed when the weather improves.

Part of the damage to the roof is due to the deteriorating condition of the building. It appears to have been constructed without proper foundations and the south west corner has sunk, causing the brickwork to crack. In some areas, the mortar has failed, leaving the bricks loose and in danger of falling out. We will continue to monitor the movement but the long term solution is to reconstruct the shed completely on proper foundations.

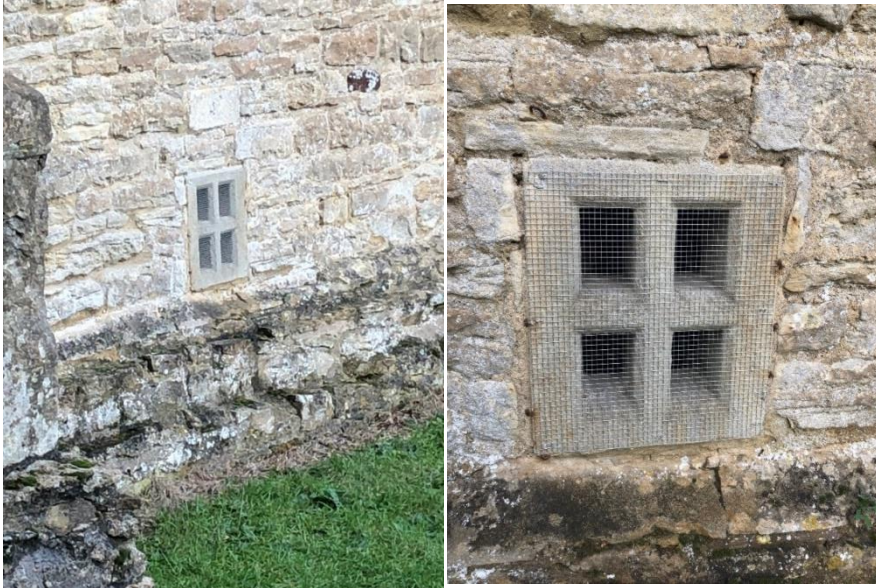
When the underfloor heating system was installed in the Victorian era, large vent bricks were installed at the bottom of the walls around the church. Unlike modern vents, these provide ready access to the underfloor area for vermin. At some time in the past, the vents had been covered with galvanised chicken wire. Over the years this has rusted away and become unsightly and ineffective. We have replaced this with new finer gauge mesh which provides better protection against smaller creatures and is less visually intrusive.

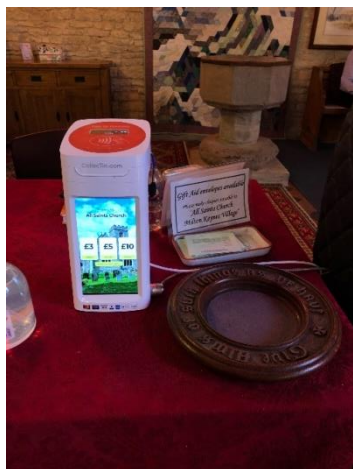
Following the pandemic, we have not reintroduced the collection plate. Whilst we do have a plate at the back of church, many fewer people are carrying cash. To enable those who don't carry cash to donate to the work of the church and other charities, we purchased a card reader. The reader, accompanied by a screen, allows donors to select a donation amount and pay by card, phone or smart watch. In the six weeks to December 31<sup>st</sup>, we collected over £420 for church funds, much of which we would have been unlikely to collect as cash.

The payment terminal relies on having good internet access to update itself and process card transactions. It occasionally shuts down or rejects transactions due to the inconsistent mobile data signal achievable inside the church and a more reliable data connection may be required.
